MISCELLANEOUS PAPER SL-81-14

# EVALUATION OF CONDITION OF LAKE SUPERIOR REGULATORY STRUCTURE SAULT STE. MARIE, MICHIGAN

June 1981  
Final Report

Prepared for U. S. Army Engineer District, Detroit  
Detroit, Michigan 48231

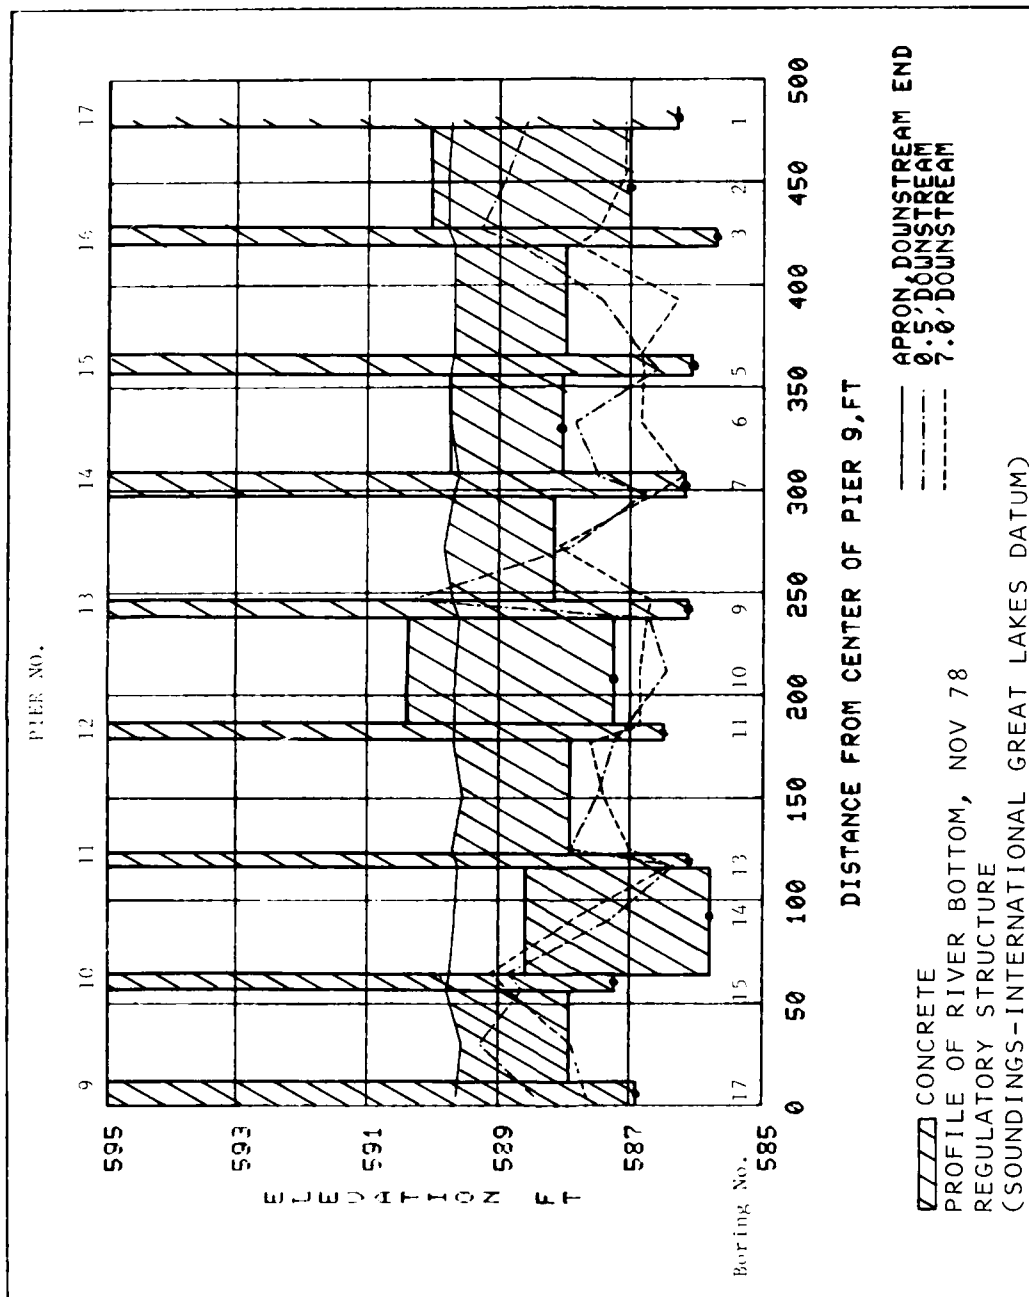
60. Soundings at the Regulatory Structure were taken most recently in 1978-79 by personnel at the Sault Locks. The results of the soundings are presented in plan view on drawing DC-103-25, dated January 1979, and titled "Compensating Works Condition Survey - 1978"; the drawing is on file at the Area Engineer Office, Sault Locks. Selected elevations along certain sections, concrete thicknesses from boring logs, and underwater videotape pictures were used to study undercutting and bedrock scouring in front of and behind the dam. See Figures 17 and 18 for profiles containing soundings and concrete thickness data.

Figure 17. Downstream profile of soundings and concrete thickness data

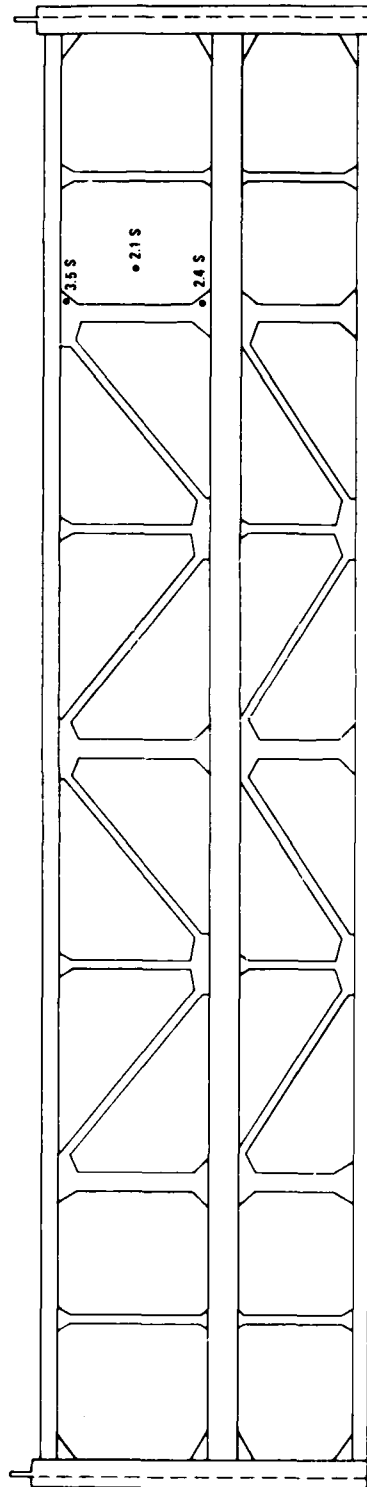
PLATE B7

**DETAILED TESTING  
LAKE SUPERIOR REGULATORY STRUCTURE  
UPSTREAM SIDE, GATE 16**

NOTE: MEASUREMENT OF RIVET LENGTH IN INCHES  
 S = ULTRASONICS INDICATED SAME AS ACTUAL  
 MEASURED LENGTH  
 B = INDICATES CRACKED RIVETS

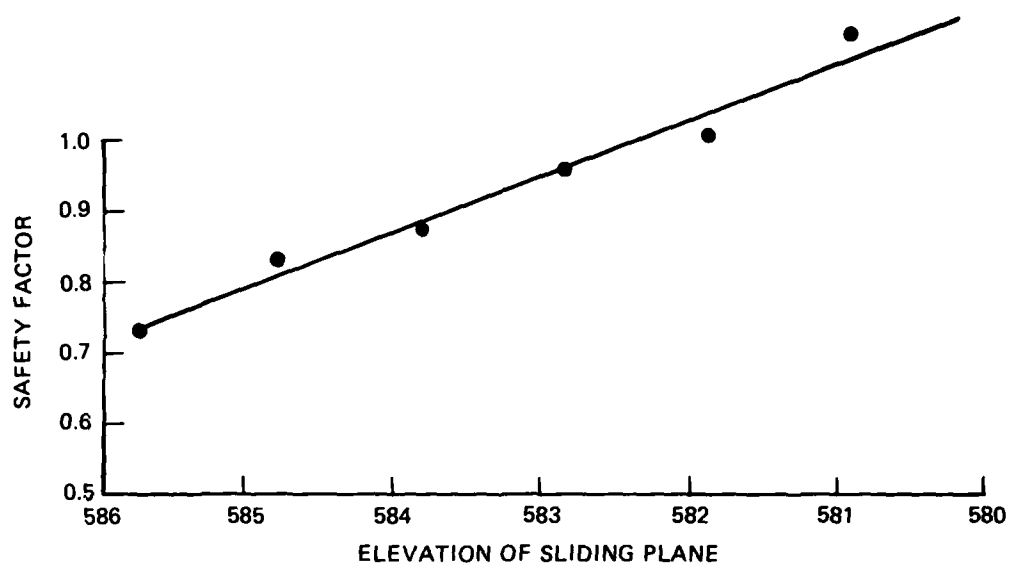
16. The results of the preliminary stability analysis indicated that the piers were adequate in their resistance to overturning and base pressures and were probably inadequate in their resistance to sliding.

Figure F1. Safety factor versus elevation of sliding plane in foundation

The concrete piers were found to be adequate in their resistance to overturning and base pressure, but inadequate to sliding. Remedial stability measures are recommended.
